PHASE I INSPECTION REPORT
NATIONAL DAM SAFETY PROGRAM

**DELMOE LAKE DAM
BUTTE, MONTANA
JEFFERSON COUNTY
MT-117**

PREPARED BY:
CH2M HILL
BELLEVUE, WASHINGTON

APRIL 1980

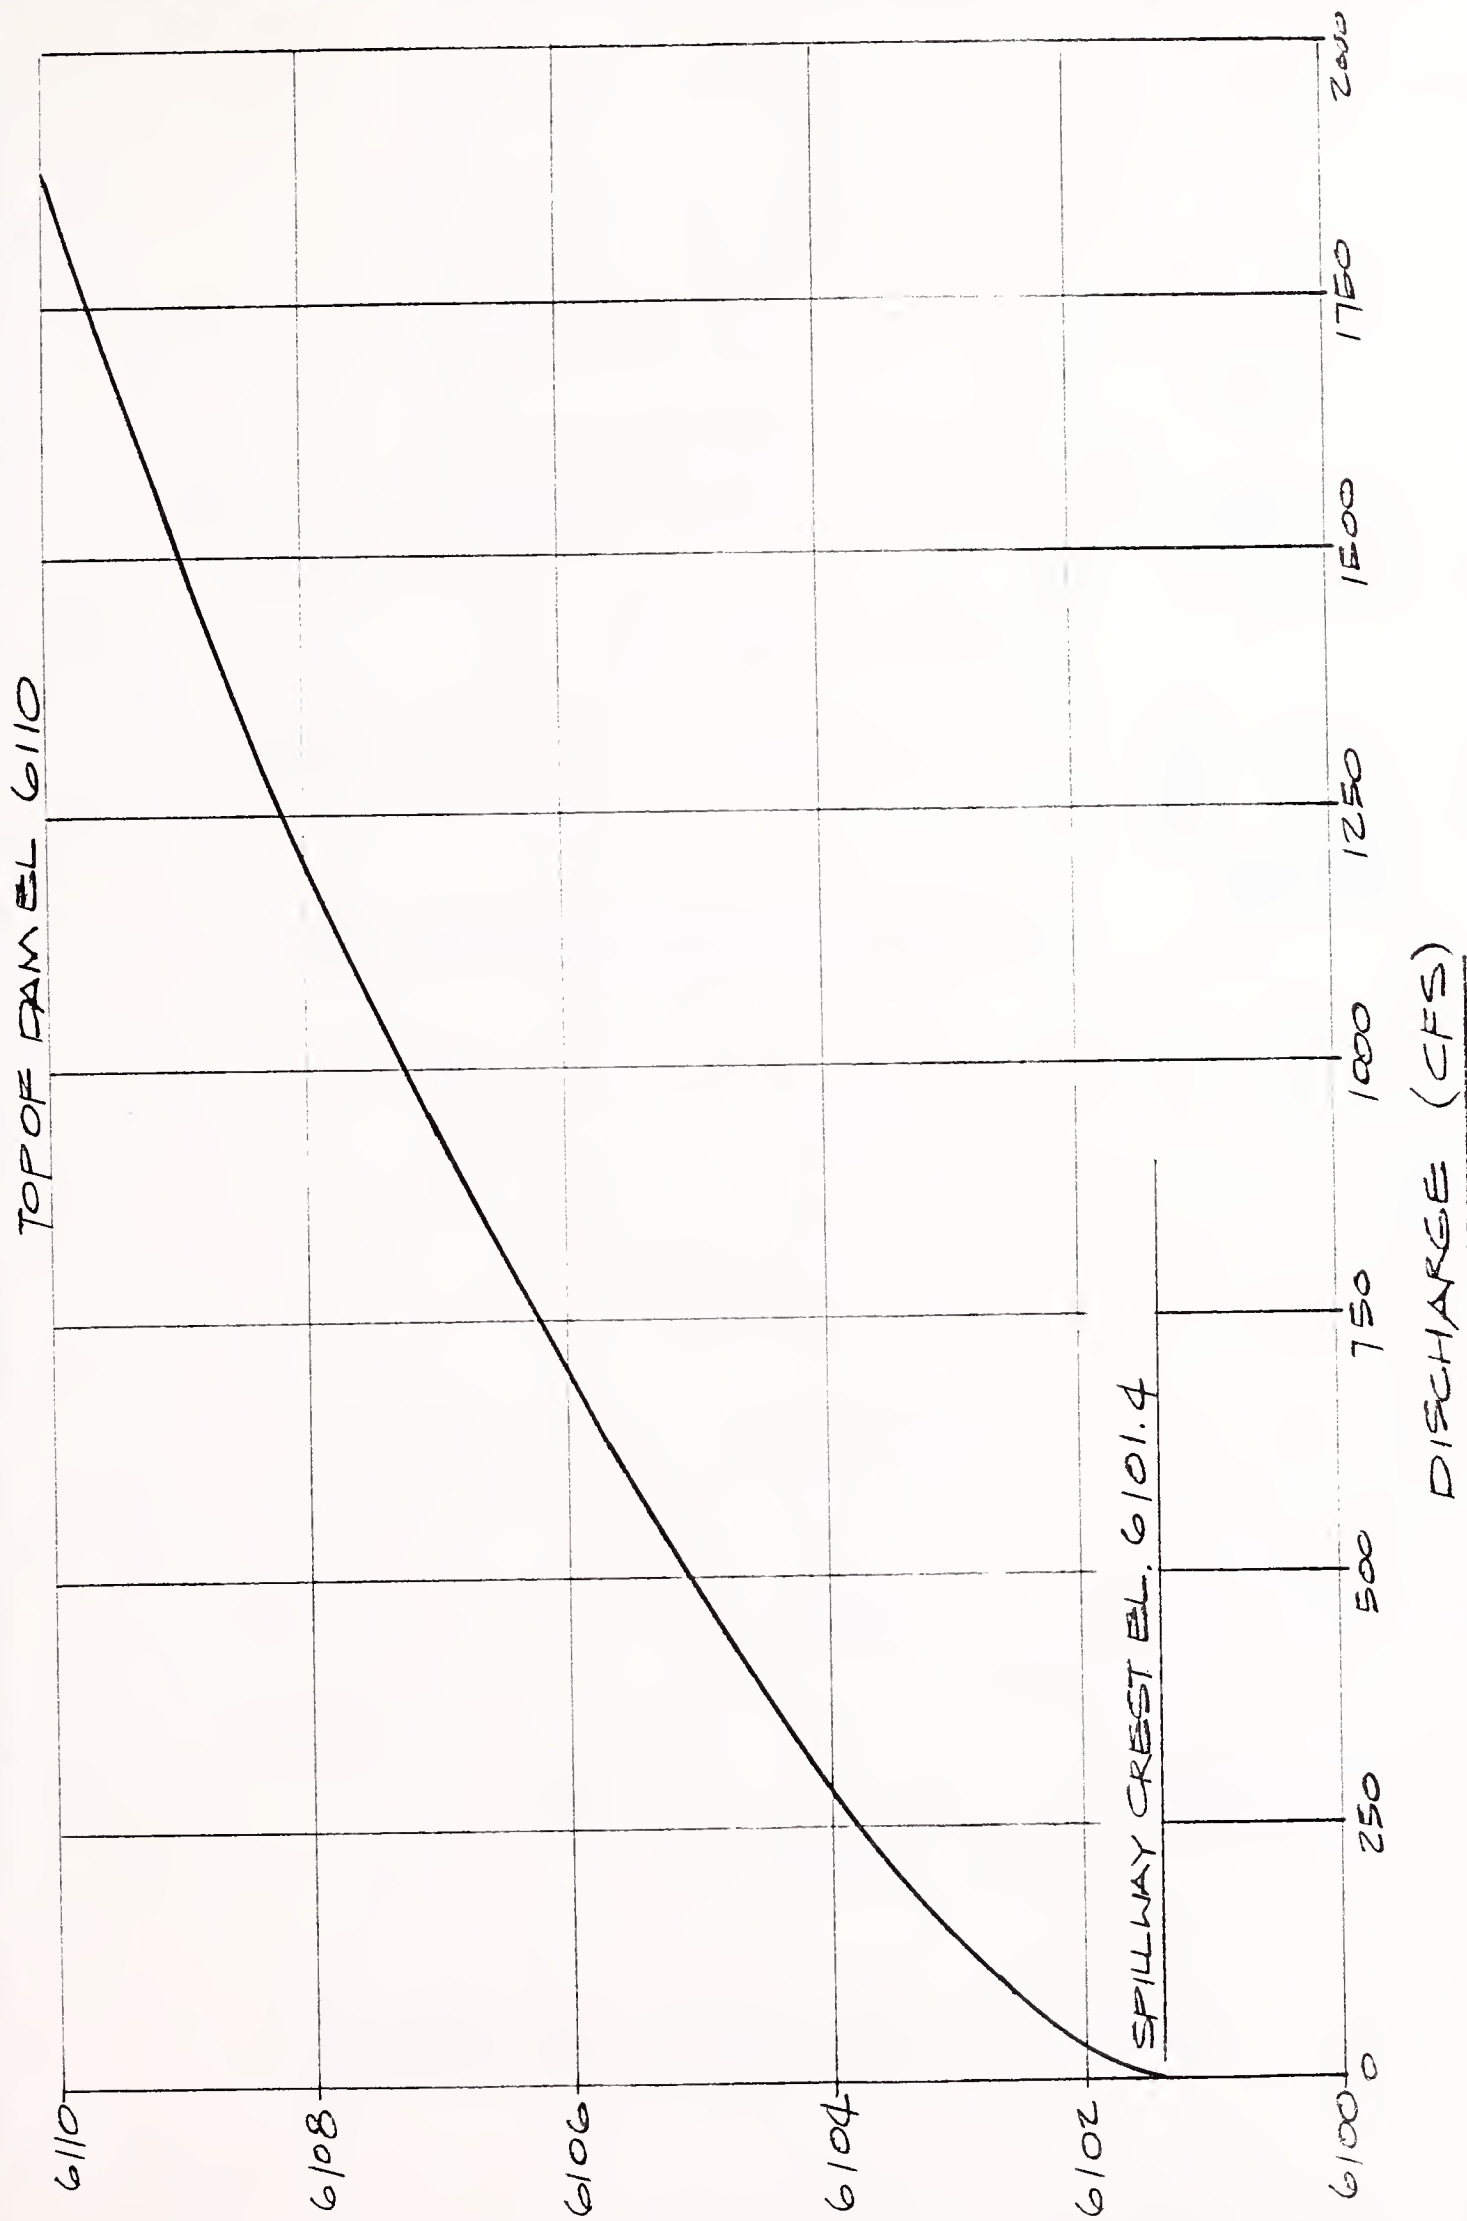
PLATE 3

The spillway rating was developed by assuming that critical depth occurs at the chute entrance. Backwater computations in the spillway chute, using a Manning's "n" of 0.025, revealed that the control remains at the chute entrance for all discharges. An energy loss of 0.3 times the velocity head was used to account for channel entrance conditions. The maximum discharge capacity of the spillway with the reservoir at the top of dam, elevation 6100 feet NGVD, was estimated to be 1,900 c.f.s. The discharge rating curve is presented on Plate 3.

DELMO LAKE DAM
SPILLWAY RATING CURVE

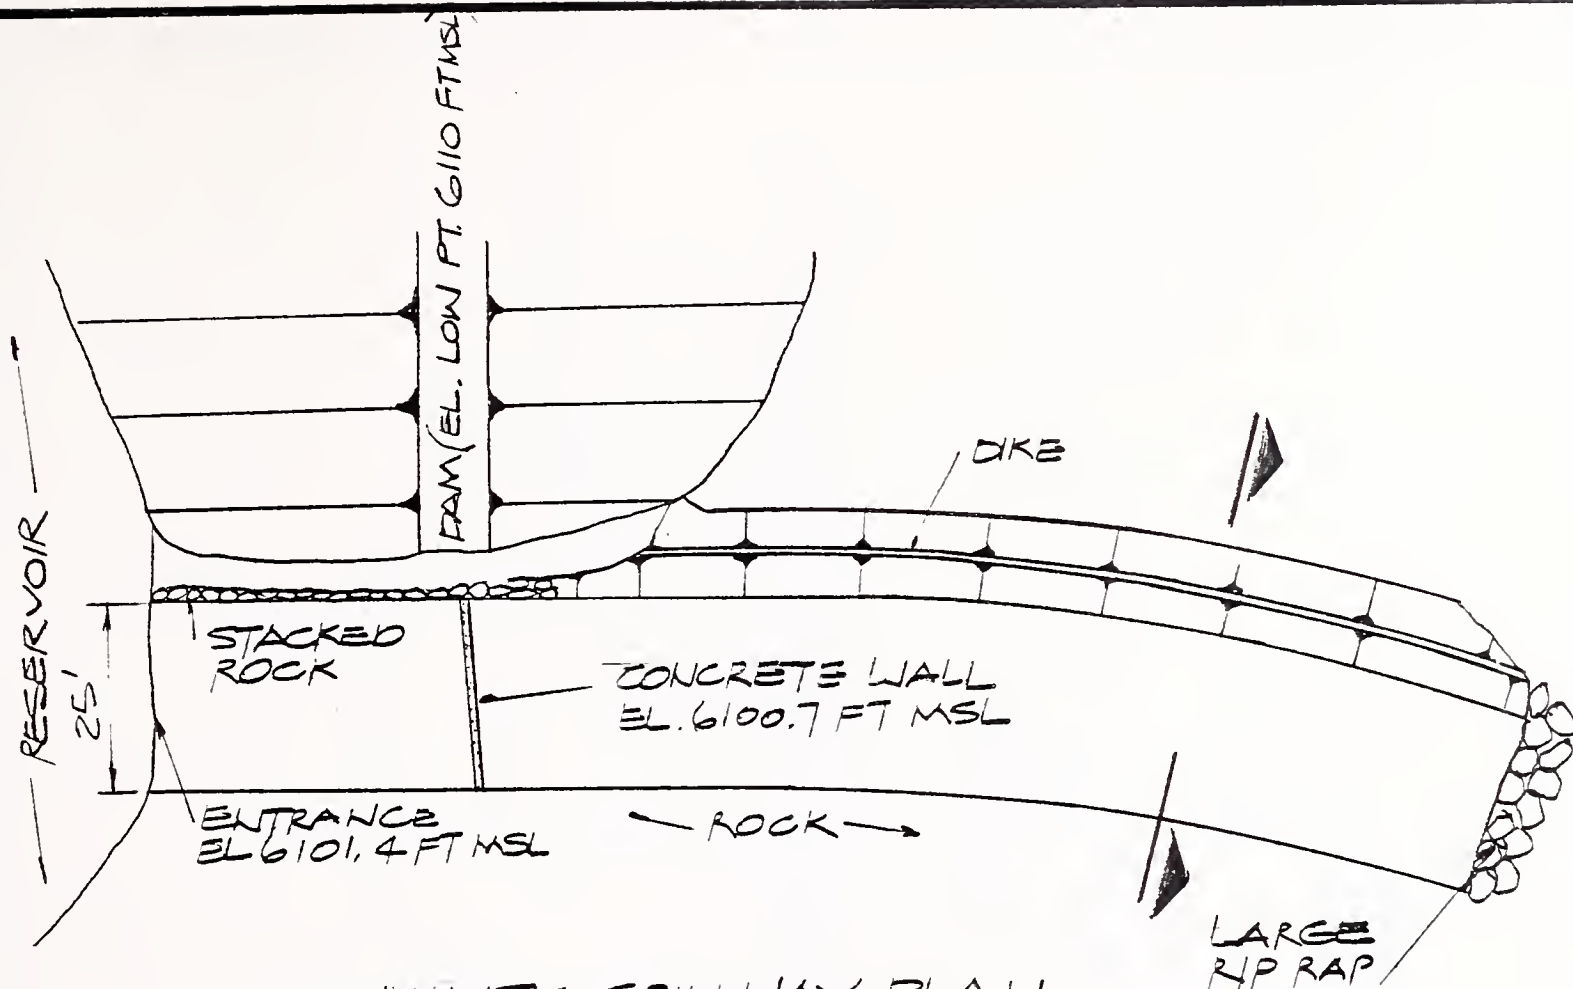
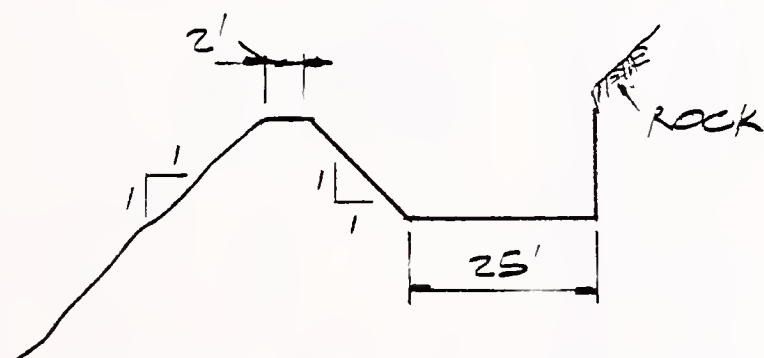
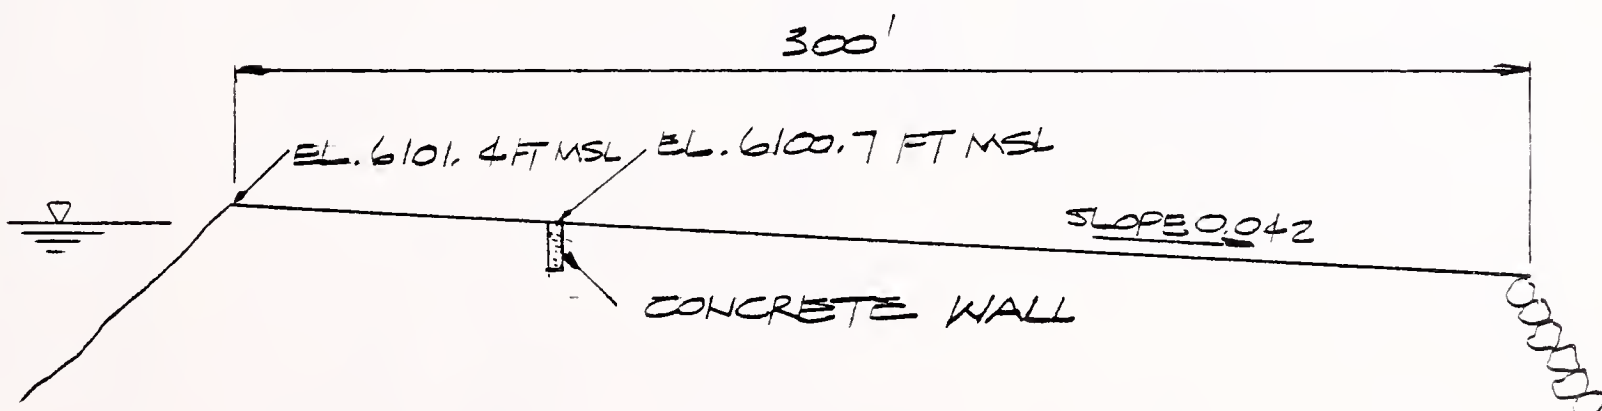
The spillway for Delmoe Lake Dam is located in natural ground at the right abutment. The spillway consists of a 300-foot-long unlined chute (Photo 4) in decomposed granite and rock with a 25-foot bottom width. A concrete wall, flush with the invert of the chute, crosses the chute about 60 feet downstream of the entrance. The top of this concrete wall is 0.7 feet lower in elevation than the chute entrance. The chute entrance invert is at elevation 6101.4 feet NGVD (based on an assumed top of dam elevation 6110 feet NGVD). At the spillway entrance, the right (looking downstream) bank has a side slope of about 1 H on 1 V but changes to near vertical for most of the length. The left (looking downstream) chute bank is cemented-in-place, vertically stacked rock from the chute entrance downstream for about 100 feet. The remaining 200 feet of the left chute bank is an earth (decomposed granite) rock dike about 6 feet high with approximately 1 H on 1 V side slopes (Photo 5). The chute makes a gradual bend to the right for its 300-foot length. The chute discharges over a steep bank protected with large riprap (some erosion exists). The chute slope averages 0.04 feet per foot downstream of the concrete wall.

A downstream warning system, for use in the event of possible dam overtopping or structural failure, must be developed and immediately placed in action. Construct a spillway log boom and reinforce the spillway dike to a point where its failure would not release flows onto the dam embankment. Inspect the entire length of both outlet conduits and repair as necessary. Provide adequately designed riprap on upstream face of dam.

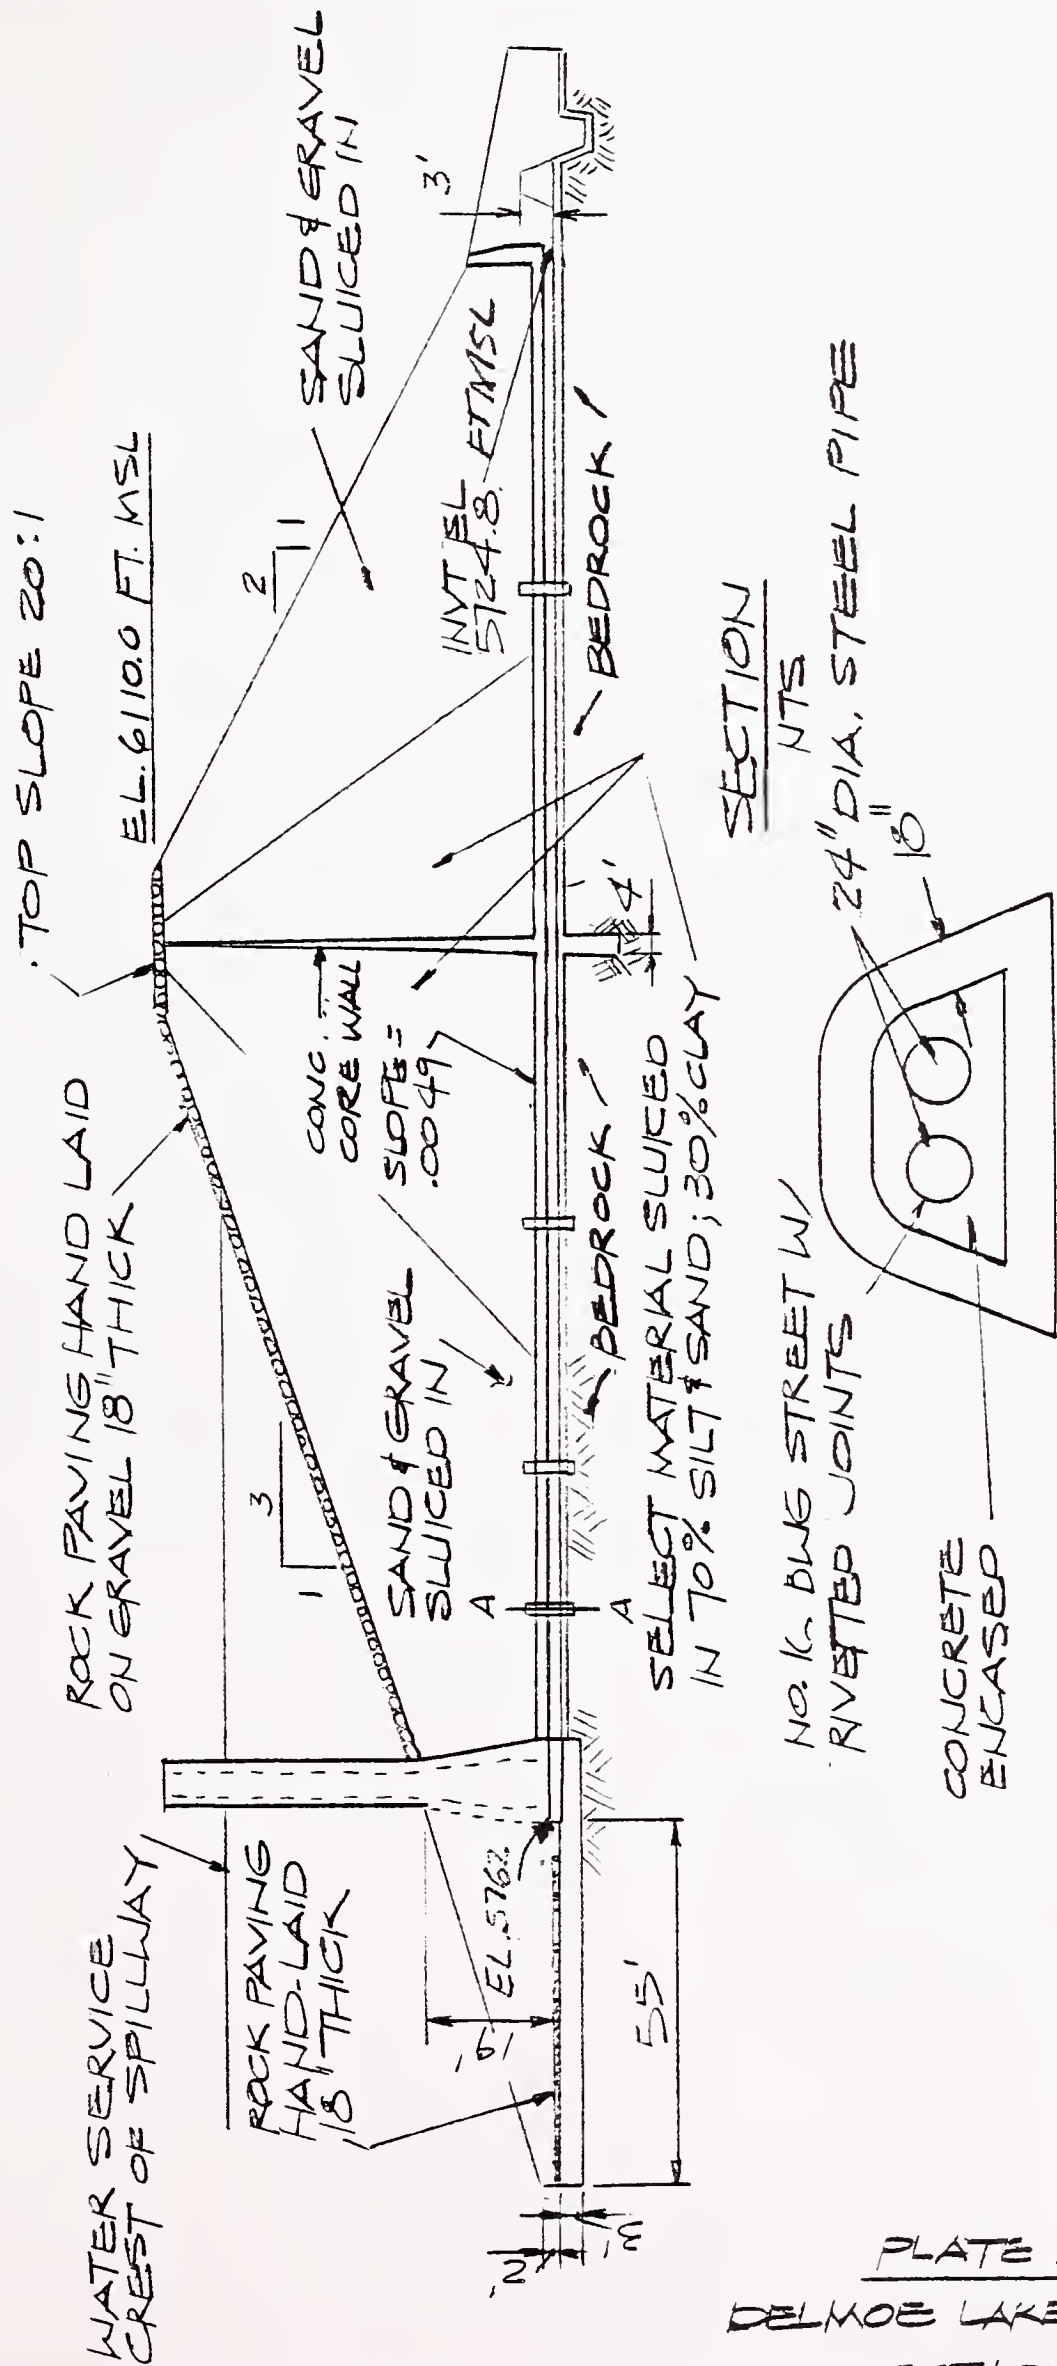
PLATE 5
DELMORE LAKE DAM
SECTION

Lake Delmoe Dam was completed about 1923. A single drawing (Plate 5) depicts construction details. The State of Montana Department of Natural Resources and Conservation files contain no information on the foundation conditions, borrow materials for embankment construction, construction control records, stability analysis, or information on hydrology or hydraulics.

upstream slope is 1 V on 3 H and the downstream 1 V on 2 H. Sketchy construction plans (Plate 5) show a central concrete diaphragm; however, plans are not clear whether the concrete diaphragm was extended to rock. The concrete diaphragm thickness varies from 4 feet at the base to 6 inches for the upper 40 feet. Plans show that the select material adjacent to the concrete diaphragm was sluiced into place and met gradation requirements of 70 percent silt and sand and 30 percent clay. Materials both upstream and downstream of the select material core are shown as sand and gravels sluiced into place.

Conduct engineering studies to evaluate embankment stability and to determine the detailed PMF. Modify the project as studies indicate for stability and capability to safely handle the PMF. Conduct periodic inspections of Delmoe Lake Dam at not more than 5-year intervals by engineers experienced in dam design and construction.
